STAFF REPORT

REFERENCE: BG112302

SUBJECT: **SALISBURY HISTORIC FOOTBRIDGE - AORERE**

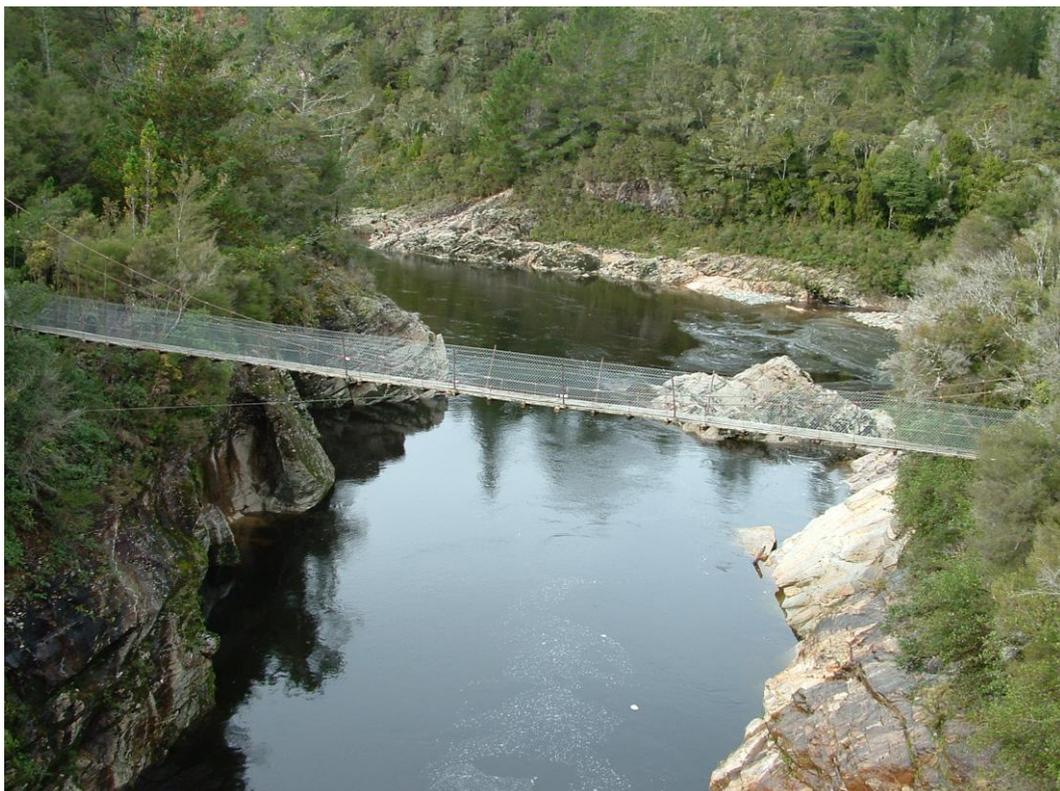
The Salisbury Suspension Footbridge was originally built for gold miners more than one hundred and twenty years ago. It is listed by the NZ Historic Places Trust (NZHPT) as a Category II Registered Heritage Structure, Number 5123. Tasman District Council has in the past made repairs to preserve the original structure. The bridge spans 36 metres across the Aorere River which is vested with Tasman District Council for management purposes.

The January 2009 inspection resulted in the closure of the bridge. Cable faults, continuing timber deterioration at previously treated sites and new locations of timber decay were reported. Repair work was recommended within six months. The urgent issues included installing more anti-sway cables to minimize stress put on the structure by overly exuberant visitors on the bridge. Work also includes better signage on the nature of the historical significance of the bridge and its dangers. There is no economic or practical way of ensuring that the load recommendation is practised by visitors who use the bridge.

The second option looked at a more affordable remedial measure which consists of replacing the existing wooden structure with second hand timber sourced from Southland. This is the NZHPT preferred choice. This option would also include additional sway cables and load testing for the completed retrofit of the structure. This option has an estimated cost of \$18,000. This work can be carried out within our current budget levels. NZHPT has granted dispensation for the use of the second hand timber for the bridge structure.

6.1 THAT Council approve the option to replace the existing rotting timbers with second hand timber.
