STATE OF SURFACE WATER QUALITY IN TASMAN DISTRICT

Document Status: Final Report

June 2005

Tasman District Council Ref: R05007
Cawthron Report No. 933

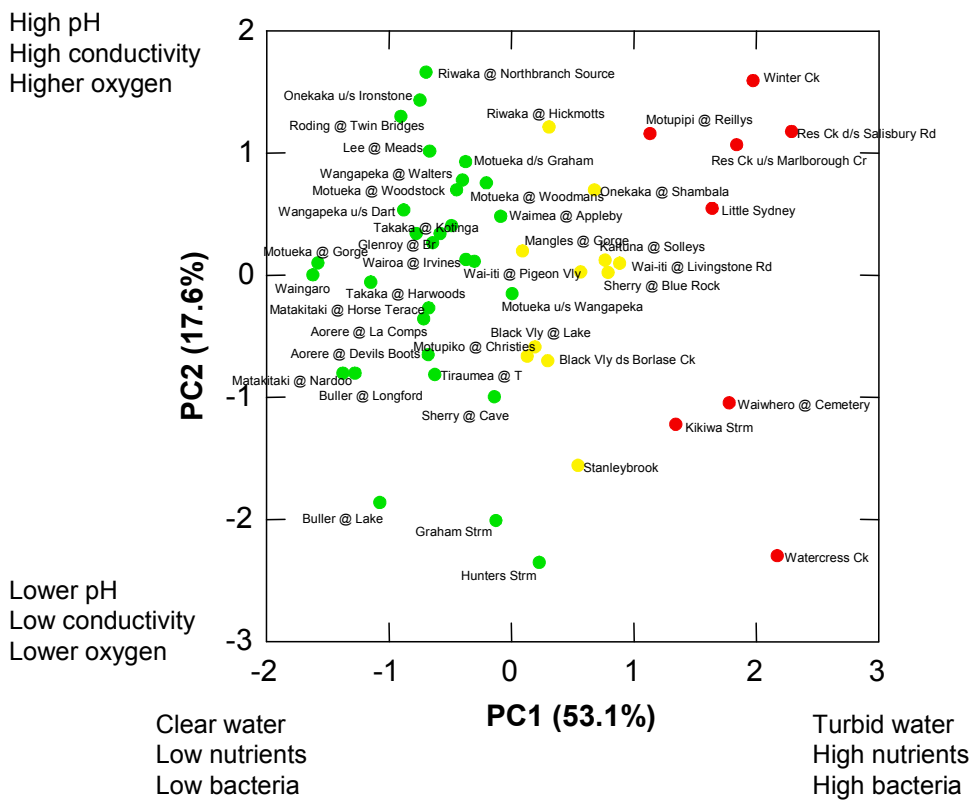
Figure 15 Ordination of sites based on their water quality
The colours refer to the site groupings from Figure 14 above.

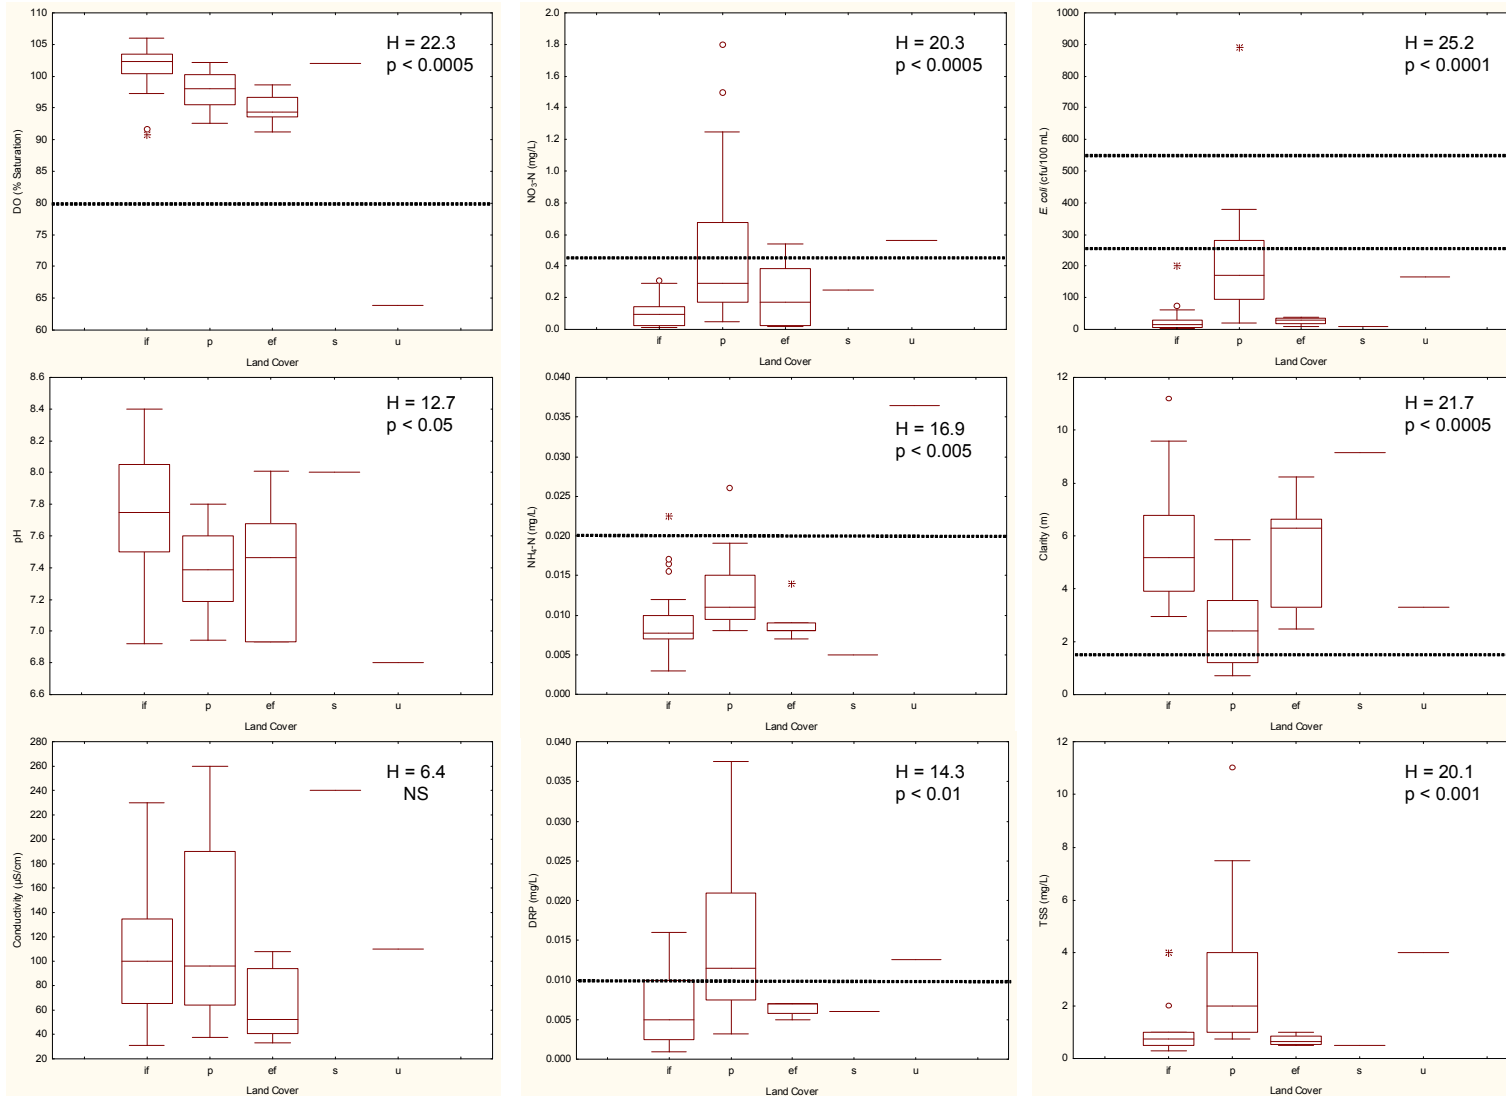
Figure 17 Comparison of median water quality parameters among REC Land cover classes. if = indigenous forest, p = pasture, ef = exotic forest, s = scrub, u = urban . H-statistics and p-values from the Kruskal-Wallis tests are shown for each water quality parameter. Water quality guidelines are shown with dotted lines where appropriate.

Significant differences were also found among the land cover classes for dissolved oxygen, pH, TN, NO₃-N, NH₄-N, DRP, TP, *E. coli*, clarity, turbidity, and suspended sediments. Concentrations of nutrients, *E. coli* and suspended sediment at sites classified as having pastoral land cover were higher than at sites with indigenous

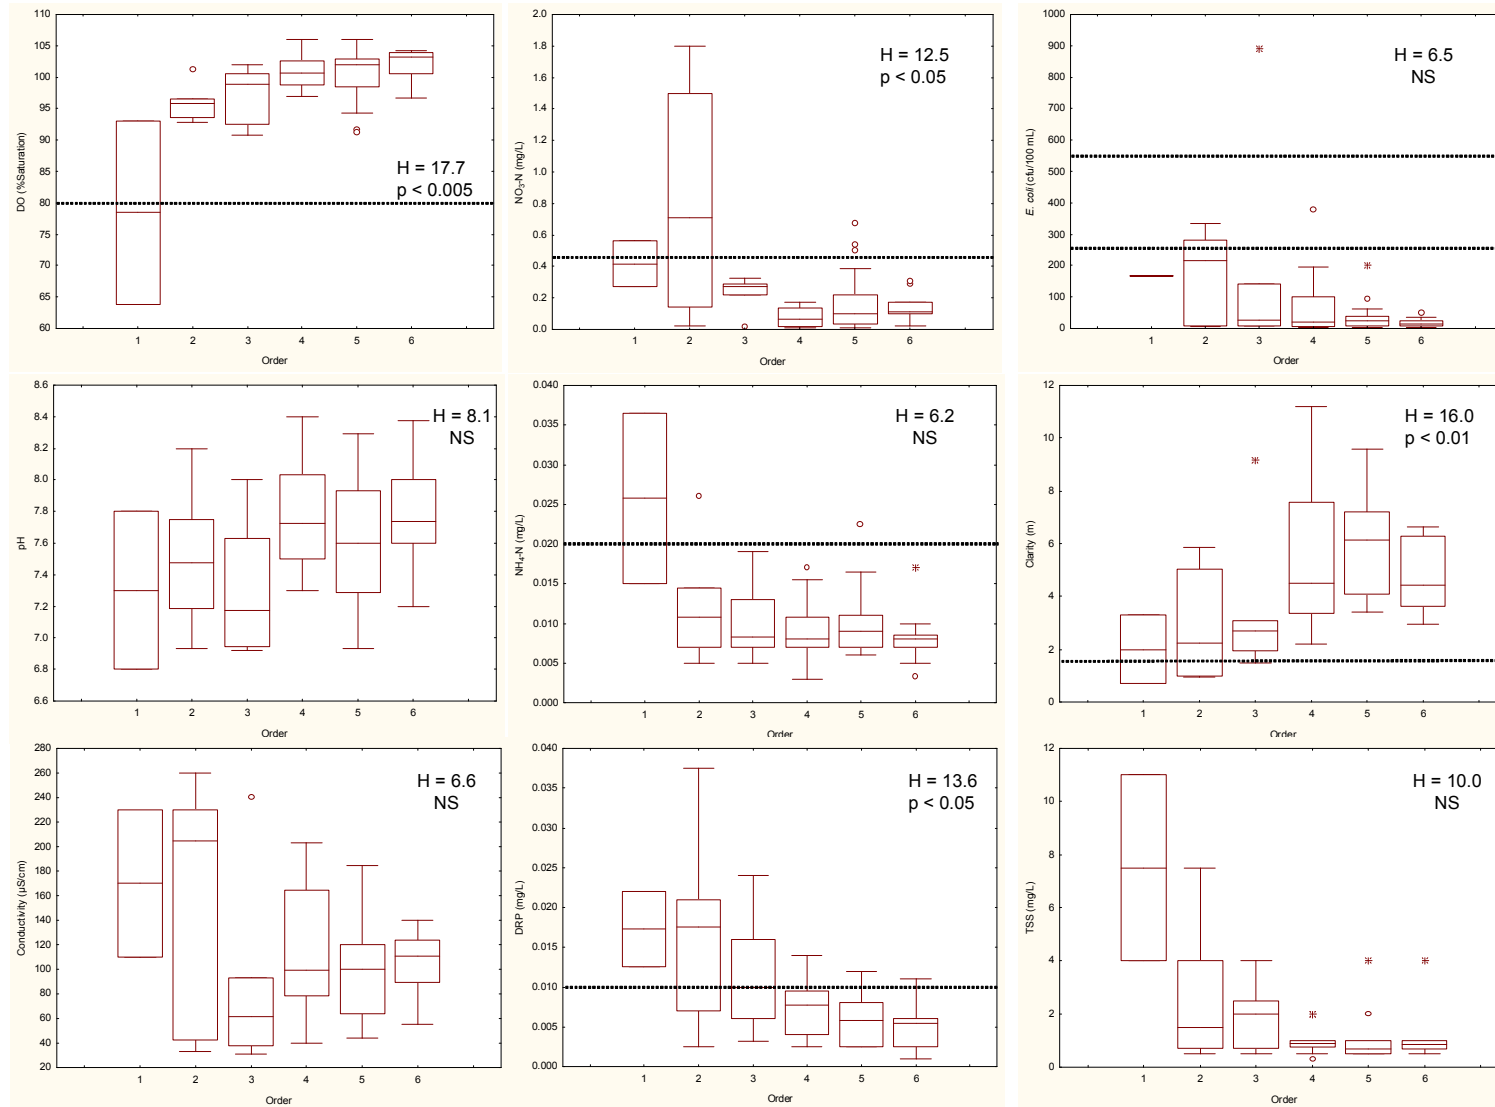
Figure 18 Comparison of median water quality parameters among REC stream order classes. Two first order streams join to form a second order stream, two second order streams join to form a third order stream etc. H-statistics and p-values from the Kruskal-Wallis tests are shown for each water quality parameter. Water quality guidelines are shown with dotted lines where appropriate.

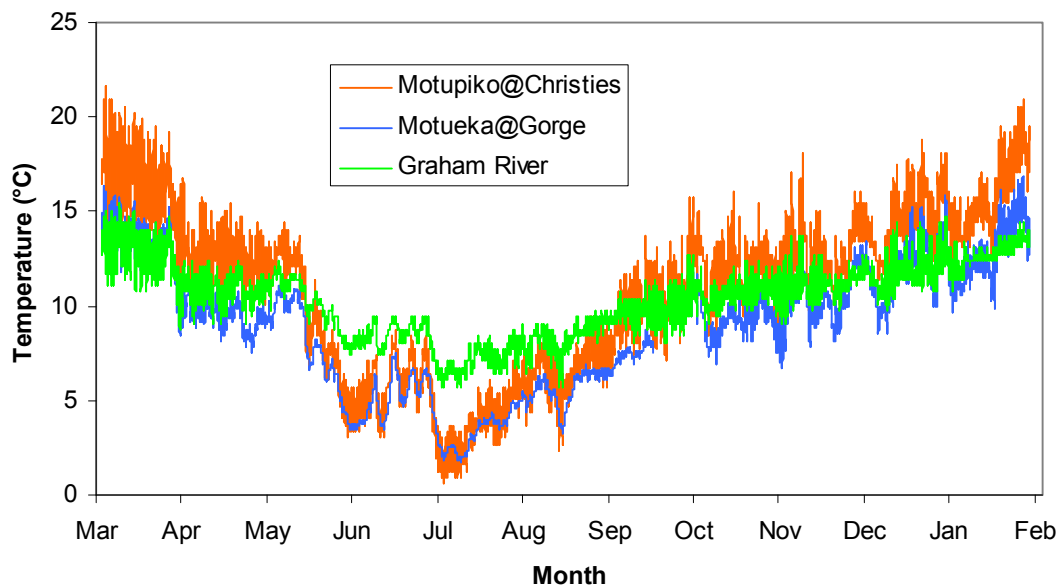
Figure 19 Yearly changes in water temperature at three contrasting sites in the Motueka River catchment

Temperature loggers (Onset StowAway Tidbit or TruTrack TH-R) have been deployed at 23 sites in the Motueka Catchment as part of the ICM programme. A logger has also been deployed in the lower reaches of the Owen River as part of Cawthron's backcountry fishery research. These loggers were programmed to record temperature every hour and operated from at least March 2001 to February 2002. An example of the full temperature record at three contrasting sites is shown in Figure 19. The Motupiko Rv at Christies site experienced very warm temperatures in summer and very cold temperatures in winter. The Motueka Rv at Gorge site had similar cold temperatures in the winter but water temperatures in the summer were much cooler than in the Motupiko Rv. The Graham Rv drains marble terrain and thus much of the water spends time underground before flowing down the river. Therefore, temperatures at this site remained relatively constant throughout the year, with cool water temperatures in the summer and relatively warm temperatures in the winter. It is also worth noting the large daily fluctuations in temperature at the Motupiko Rv at Christies site in the summer, compared with the relatively small daily variations in the Graham River.

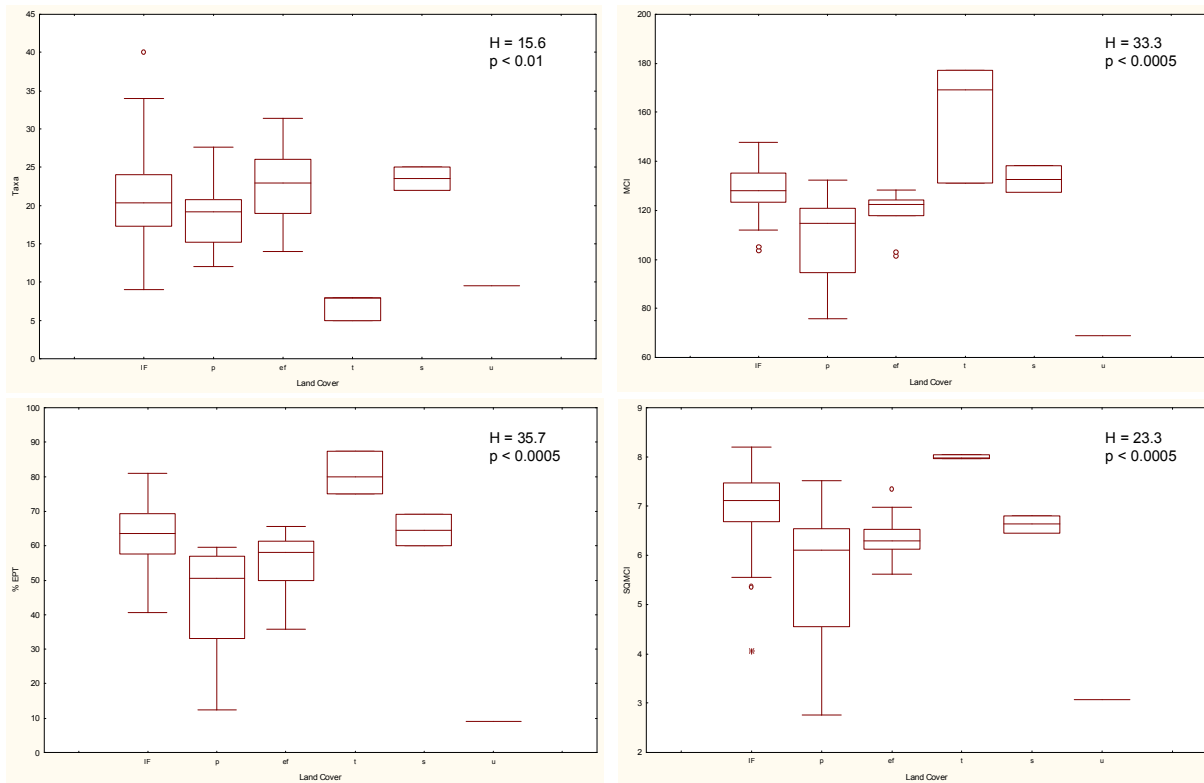
Figure 29 Comparison of average invertebrate indices among REC land cover classes. if = indigenous forest, p = pasture, ef = exotic forest, t = tussock, s = scrub, u = urban . H-statistics and p-values from Kruskal-Wallis tests are shown for each index.

There were also strong differences in invertebrate index scores among the REC land cover classes (Figure 29). The urban and tussock sites had low taxa richness compared with the other groups of sites, while the invertebrate community in the urban and pastoral sites had a lower percentage of EPT taxa (mayflies, stoneflies and caddis flies) than the other groups of sites. The MCI and SQMCI scores indicated relatively poor health in the urban stream (Watercress Ck) and in many of the pastoral streams, while stream health in the indigenous forest, exotic forest, tussock and scrub sites was generally high.

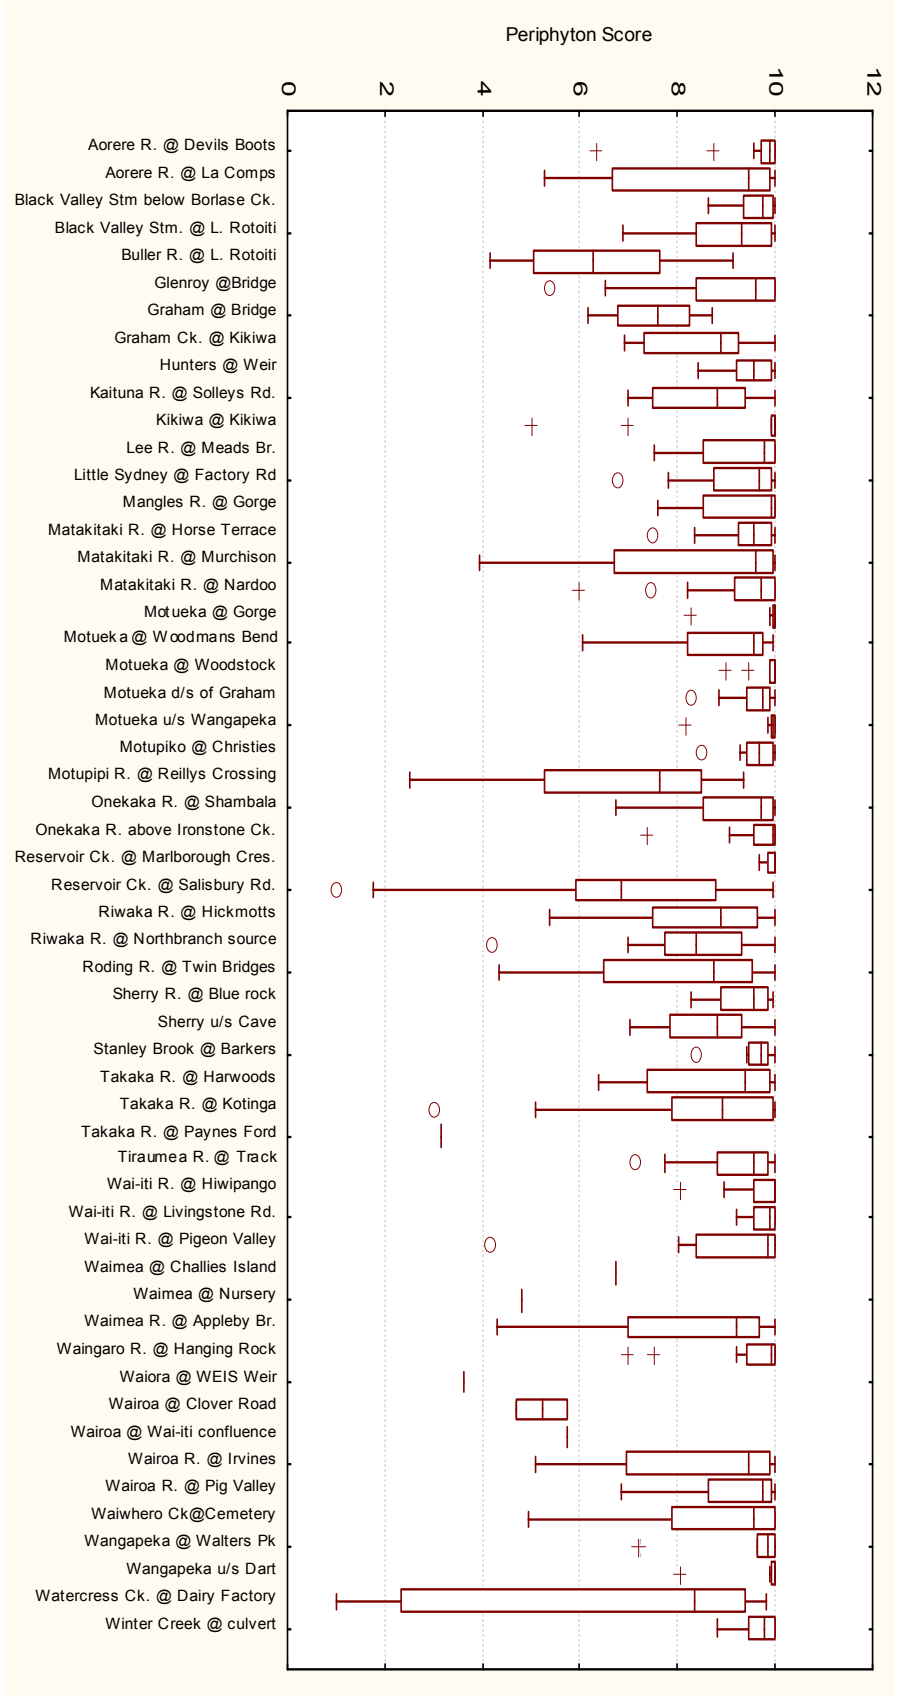
Figure 30a Box plot of periphyton scores at monitoring sites in the Tasman District (See text for explanation of scores, scores range from 1-10, with 10 indicating high ecosystem health).

A box plot of periphyton scores at sites throughout the Tasman District (Figure 30) shows that periphyton communities at most sites are indicative of good water quality, on the majority of sampling occasions. However, there are a number of exceptions. The Buller Rv at Lake Rotoiti outlet, Motopipi Rv at Reilly's Crossing, Reservoir Ck at Salisbury Road, Wairoa Rv at Clover Road and Watercress Ck at Dairy Factory are all notable for the large proportion of their periphyton samples that are indicative of lower water quality. There are also a number of "one-off" samples (shown as a "-" on Figure 30) that show relatively low periphyton scores, at least at the time of sampling (Figure 30). These sites are Takaka Rv at Paynes Ford, and a series of sites in the Waimea Rv catchment which were sampled during the 2001 drought (Waimea Rv at Challies Island and at Nursery, and the Wairoa Rv at WEIS Weir, Clover Rd and at its confluence with the Wai-iti Rv).

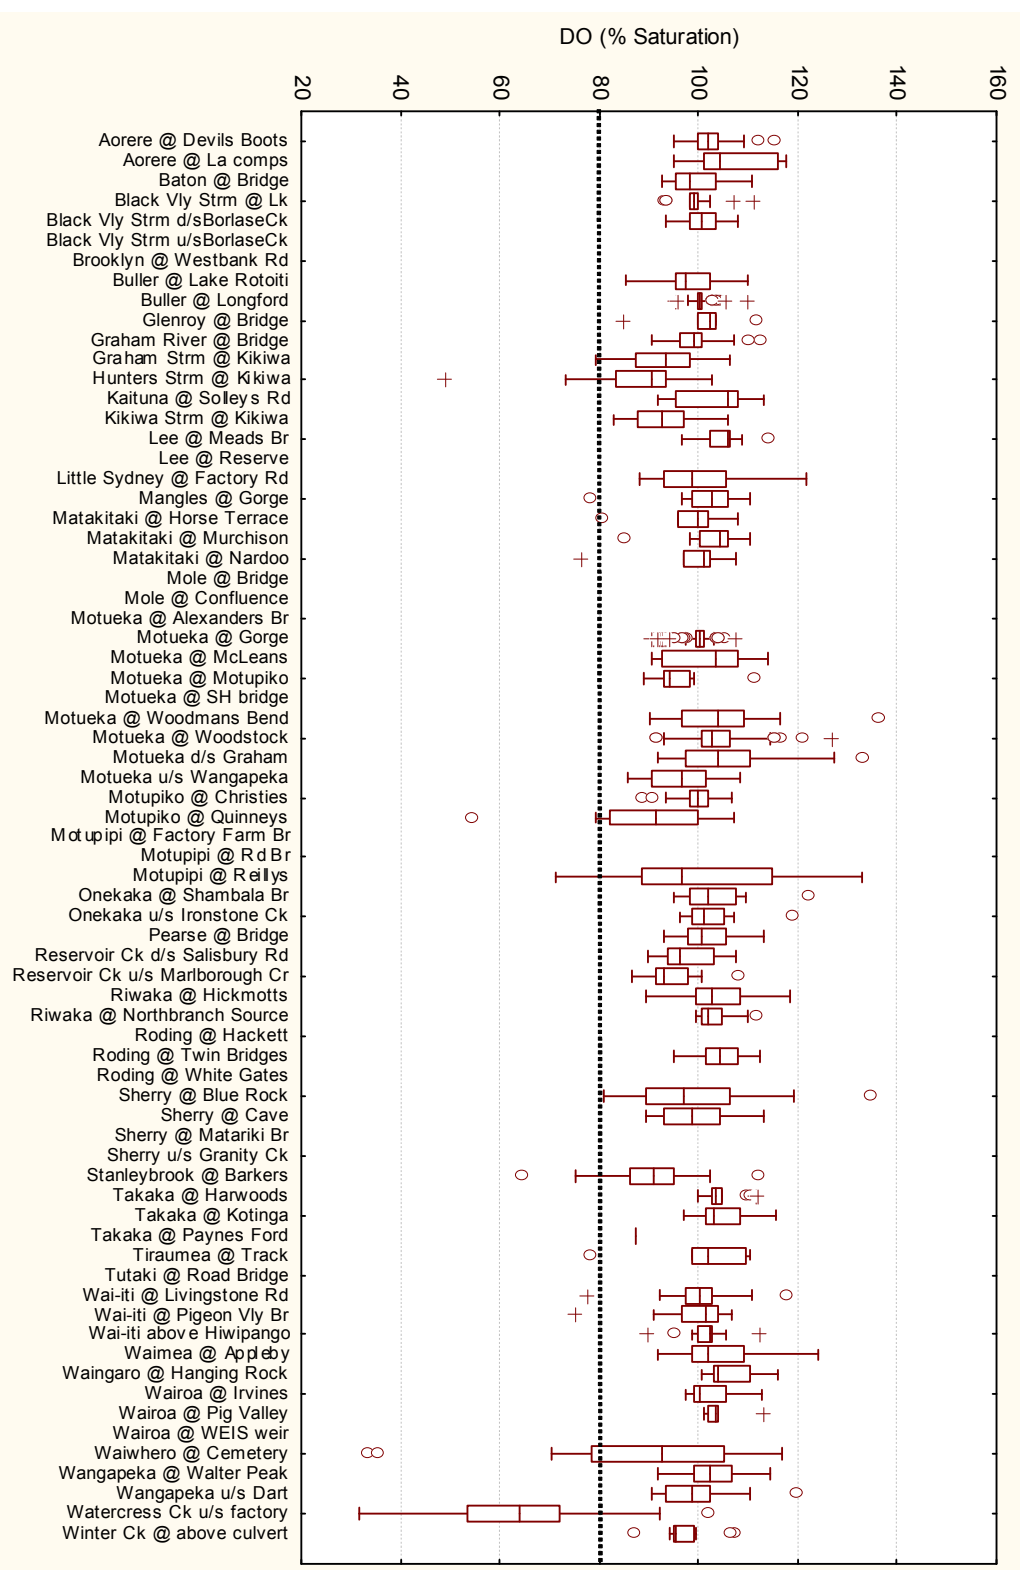
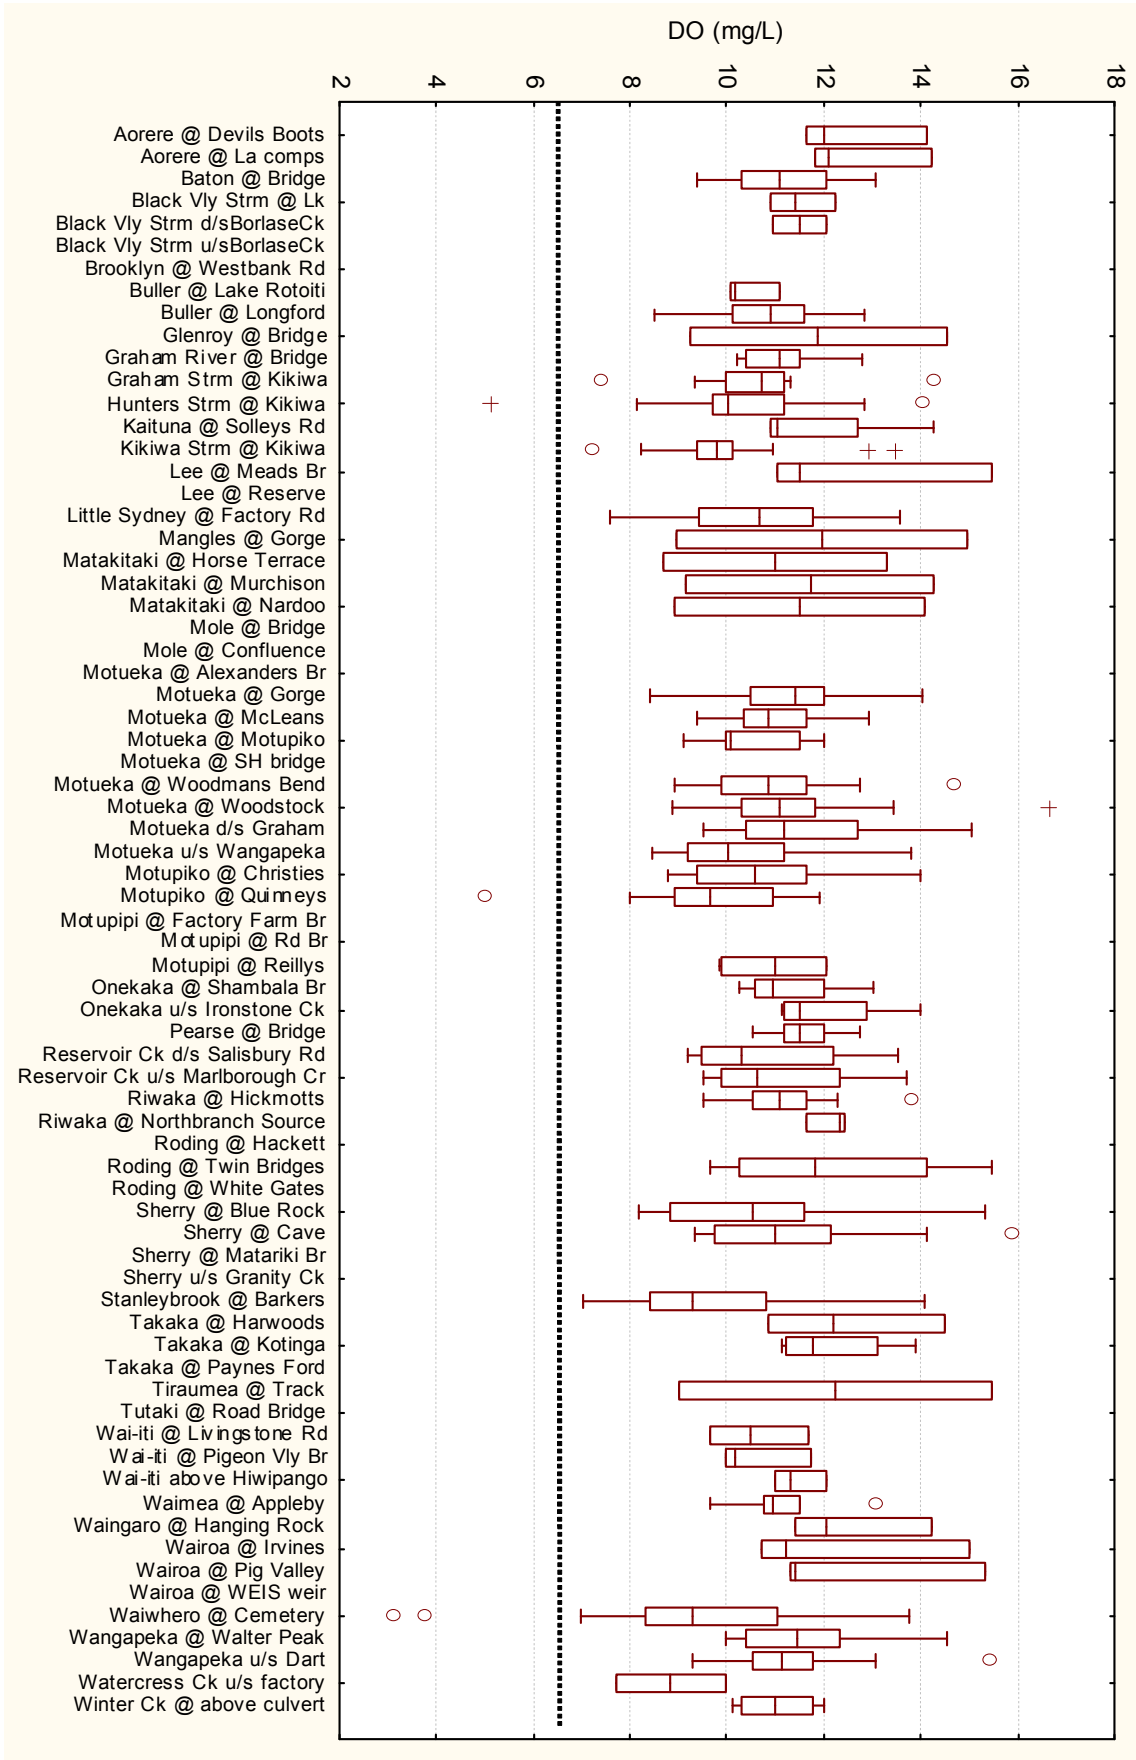
Appendix 4: Box Plot Summaries of Water Quality Data From Each Site

Each box encloses 50% of the data, with the median shown as a horizontal bar. Lines extending from the top and bottom of each box mark the minimum and maximum values that fall within an acceptable range (1.5* the size of the box). Outliers are marked with an open circle, and extreme values (>3* the size of the box) are marked with a dotted line. Note that the y-axis for some variables is on a log scale. Relevant water quality guidelines are shown with dotted lines where appropriate.
