Water Quality and Aquatic Ecology of the Motupipi Catchment

WATER QUALITY AND AQUATIC ECOLOGY OF THE MOTUPIPI CATCHMENT

Document Status: Interim Draft Report
(significant additional information will be added to this report over the next 12 months)

Tasman District Council Report Ref: 07001

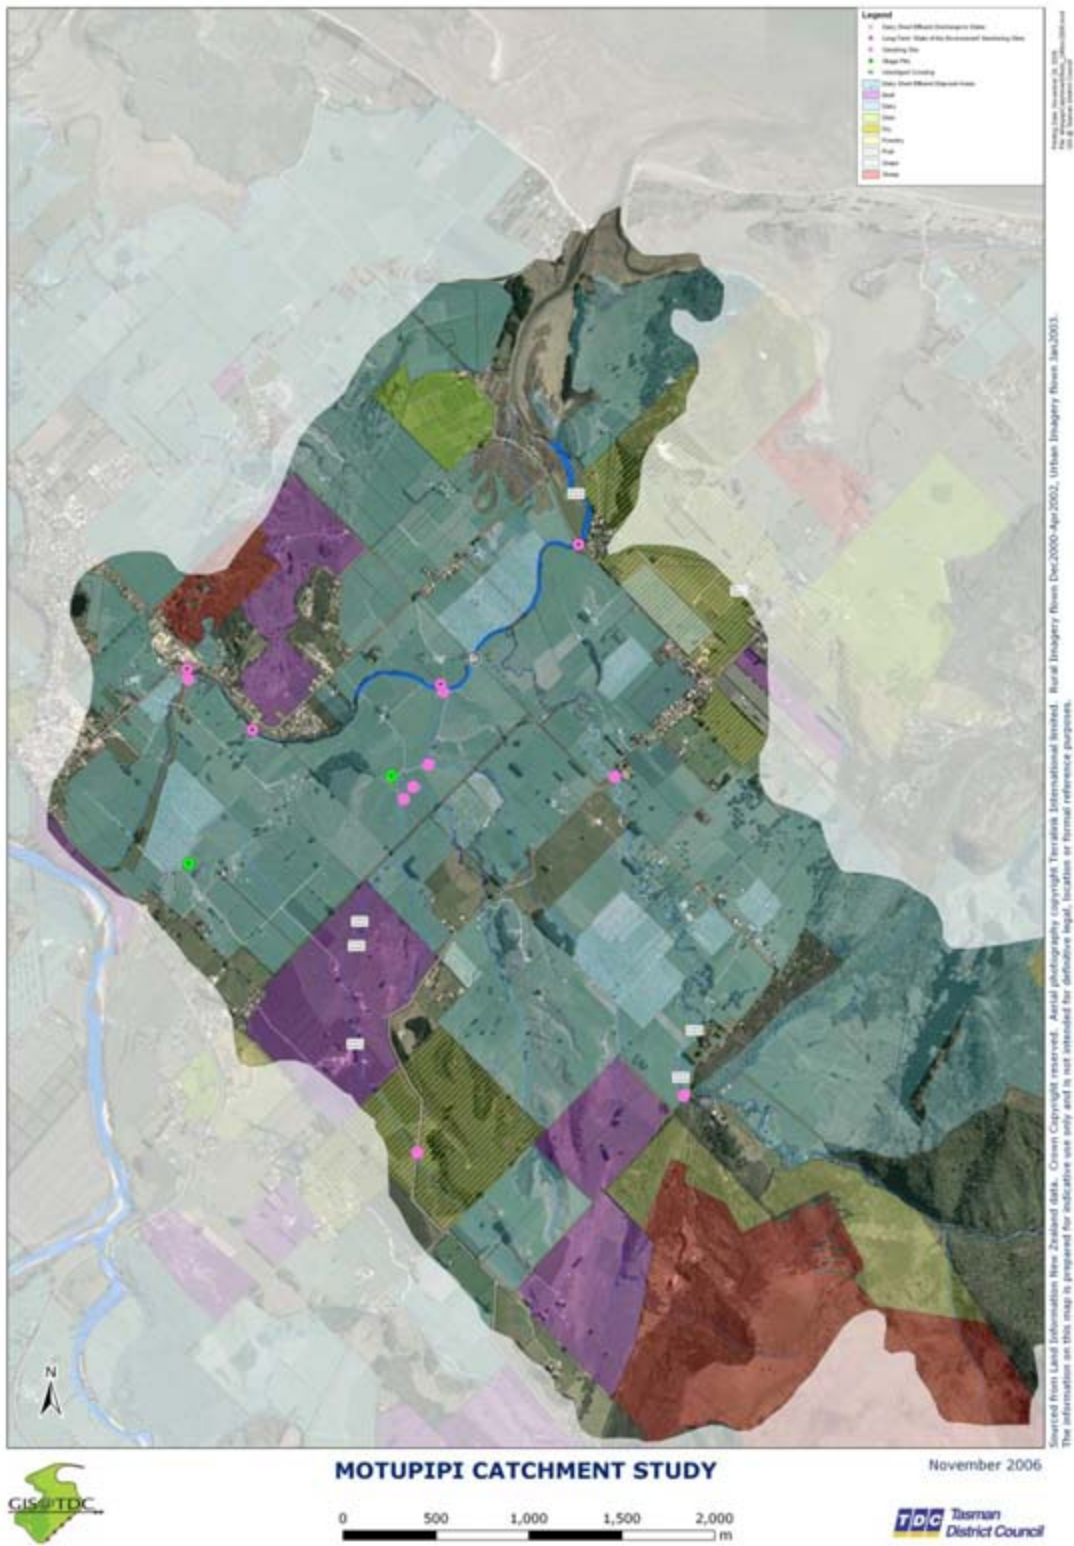
Figure 1.2: Map of the Motupipi catchment showing the major land use types, monitoring sites and other features.

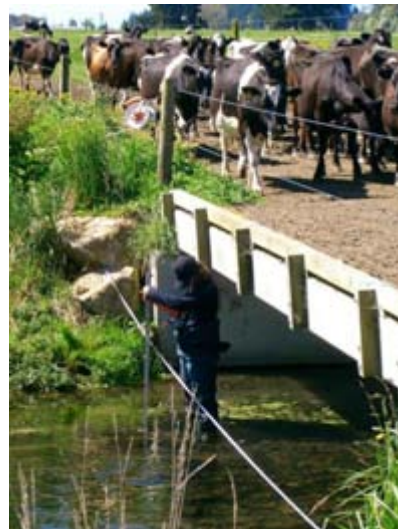
Figure 1.5 A bridged stock crossing on Reilly's farm

The main point sources of contaminants from dairy farms are typically effluent discharges, silage leachate, feed pads or wintering pads and runoff from races and stock crossings. There are three unbridged cattle crossings in the catchment, with only one of these crossing waterways with permanent flow (Motupipi River downstream of Abel Tasman Drive where the cattle cross every 4-6 weeks).

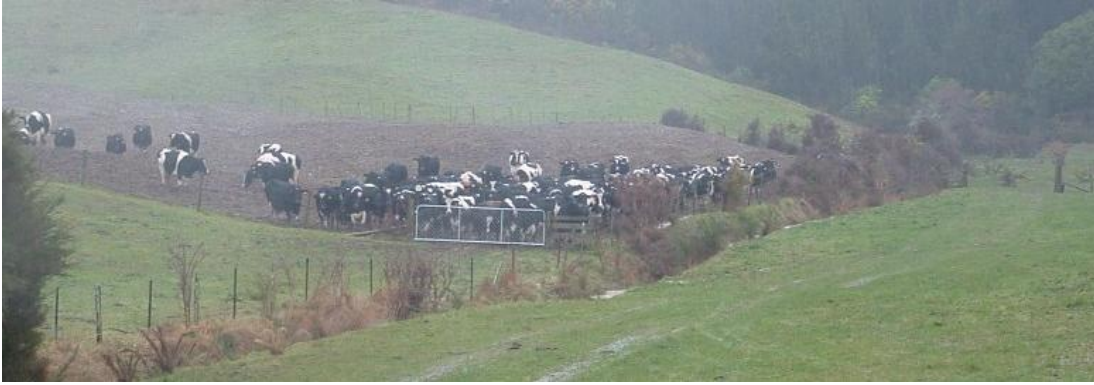
Figure 1.6 Significant pugging caused by a mob of cows during a night of rain Powell Creek sub-catchment

Feed pads or wintering off pads are used in the catchment, particularly in winter. This feed pad on clay soils has resulted in heavy pugging and run-off of fine sediment and effluent into waterways.

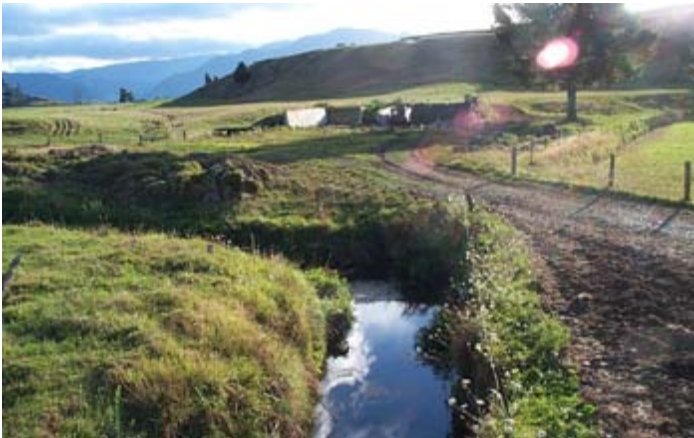
Figure 1.7 A silage pit near a waterway

Silage pits are common on most dairy farms. If poorly managed, there can be leachate discharged to waterways that can cause significant adverse effects such as oxygen depletion and excessive plant and algal growth after reasonable mixing.

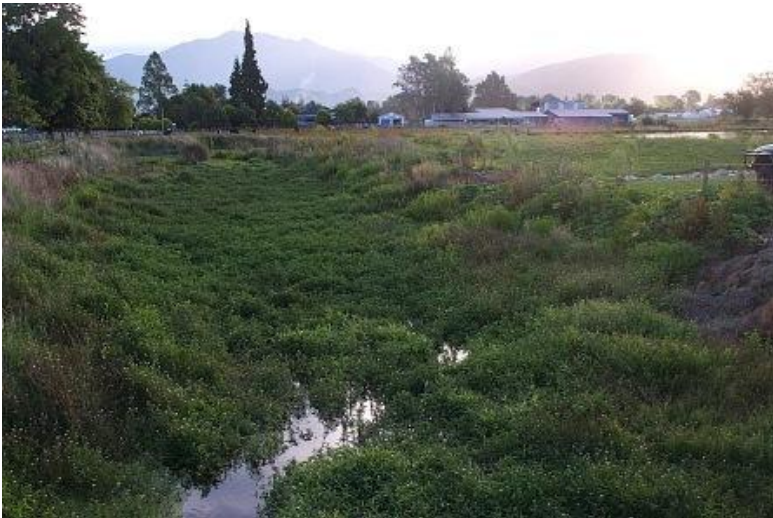
Figure 2.1 Watercress Ck @ u-s dairy factory

Most of the monitoring undertaken at sites listed in Table 1 occurs at stable baseflows, however some limited stormflow sampling has occurred in 1996, 1997 and 2006 (Thoma 1997 and unpublished results). The monitoring sites shown below are ordered from most upstream to downstream. The furthest upstream sites near the spring sources are covered with aquatic plants rooted in the bed.

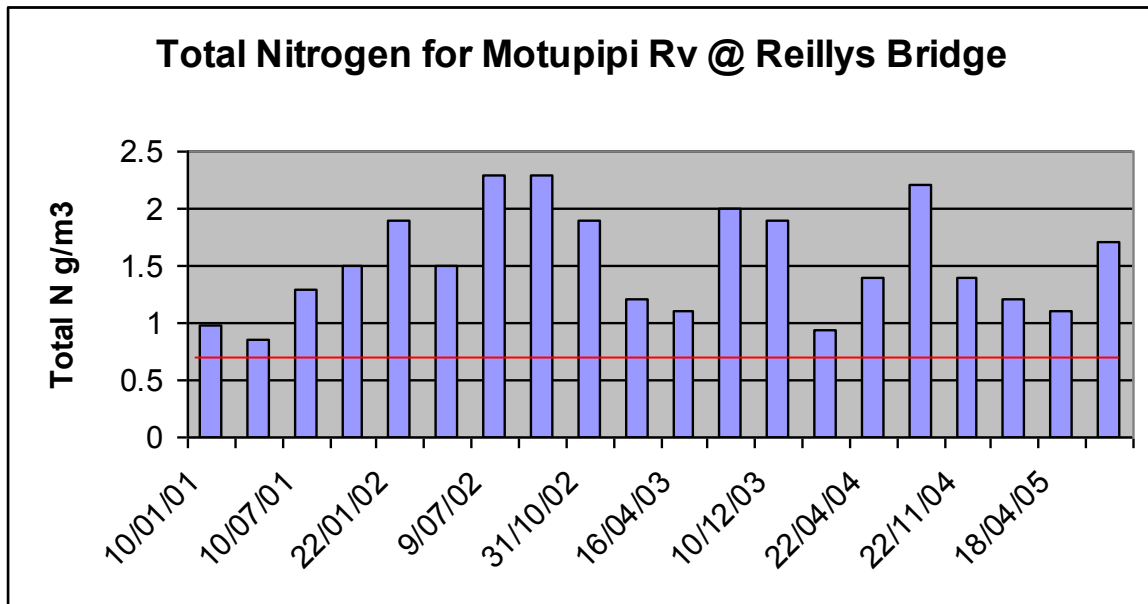
Figure 2.14b

No particular trend seems to be evident with nitrogen concentration at stable (base) flows in the Motupipi River (see Figure 2.14b).

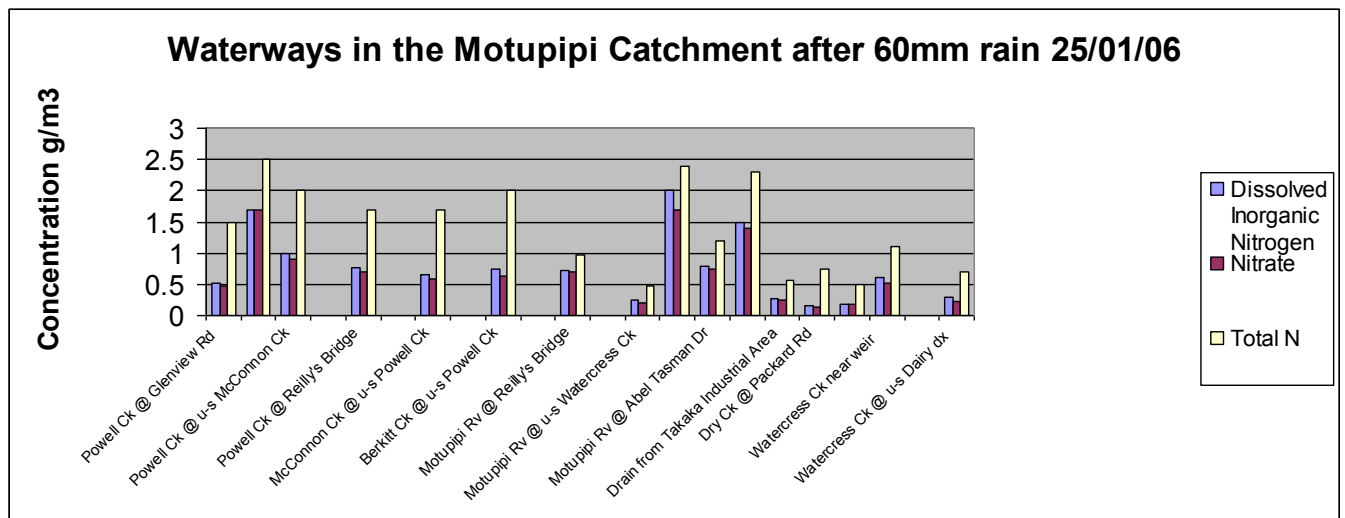
Figure 2.15

Samples taken during a storm event do not appear to cause any significant increase in nitrogen concentrations (see Figure 2.15).

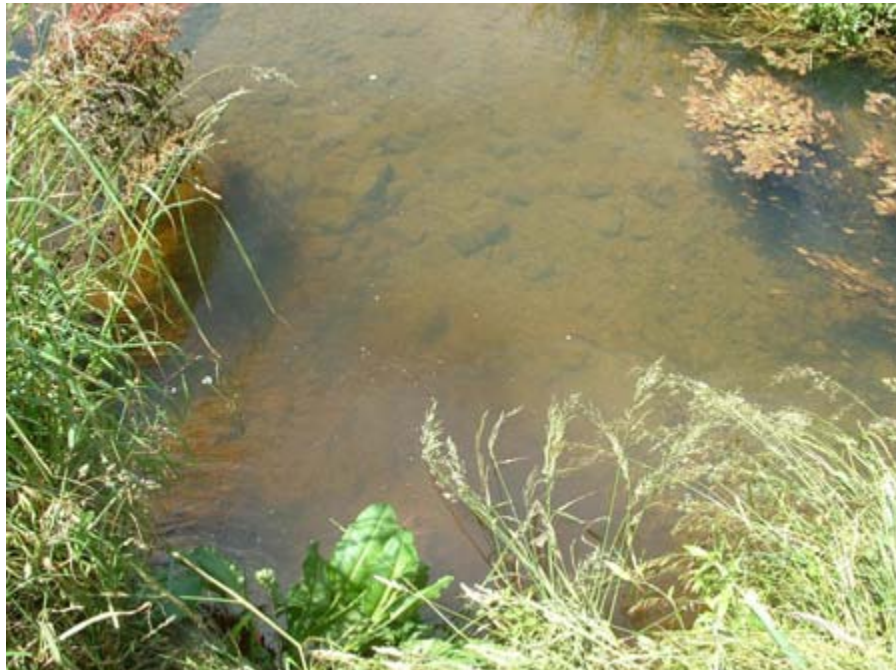
Figure 2.18 Leachate plume from a silage pit discharge.

Another contributing source could be methane (found to be bubbling out of the ground in the upper catchment near Motupipi Street) or leachate from silage pits. Both these sources contain high concentrations of dissolved organic matter and are likely to be more prevalent in spring. Photo 2.18 below shows the discharge of leachate from a silage pit in the catchment.

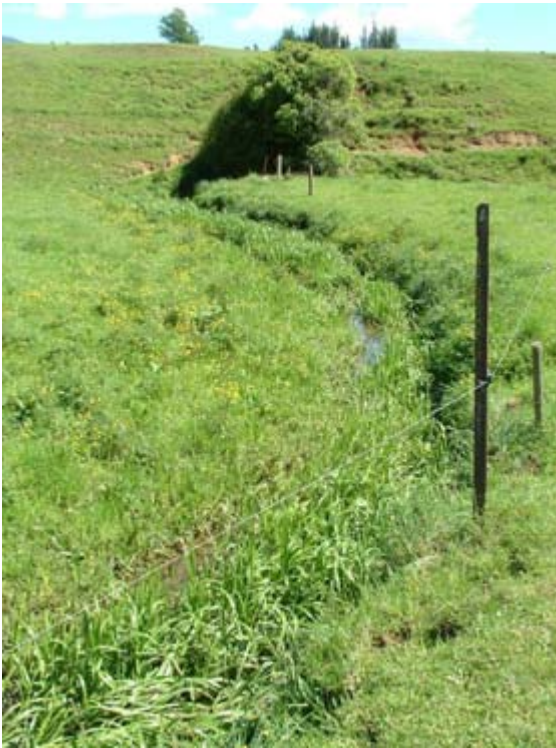
Reed Sweet Grass (*Glyceria maxima*), an invasive aquatic pest plant, was discovered in the mid and lower reaches of Powell in the early 2000's. It is currently known to exist in two locations in Tasman District (near Owen River in the Buller catchment and here). In October 2006 the extent of coverage was found to be several 100 meters of the stream, mostly upstream of McConnon Creek and downstream of the upper Reilly boundary. It can be seen in Figure 4.1 the coverage of the stream is extensive with a total affected area of the incursion estimated to be 500m². The proposed Pest Management Strategy lists this weed as a Total Control plant. Controls with herbicide have not been successful at eradicating the plant. It was sprayed hard in November-December 2006 but regrowth was evident in January 2007. It is palatable to stock so the stock exclusion in the area is likely to have allowed the plant to proliferate.

Figure 4.1 *Glyceria maxima* in Powell Ck **Figure 4.2** *Lagarosiphon major* in Te Kakau Stm

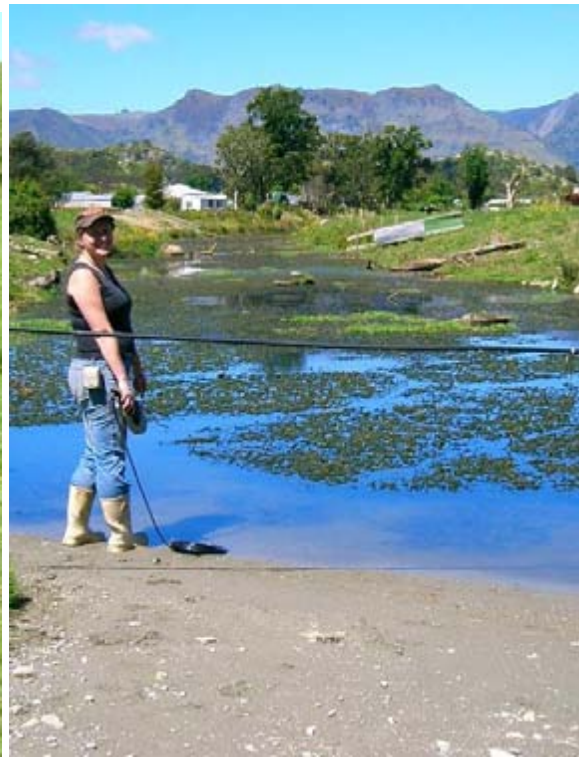
The very invasive oxygen weed *Lagarosiphon major* has the potential to spread into the Motupipi River from Lake Kilarney which is located on the very western edge of the catchment in Takaka Township. This weed is known to cause very low dissolved oxygen concentrations and block waterways as it has done in Te Kakau Stream which flows on the Western edge of Takaka. Preventing this weed from getting into the waterways is preferable to very expensive control (if it is indeed possible).

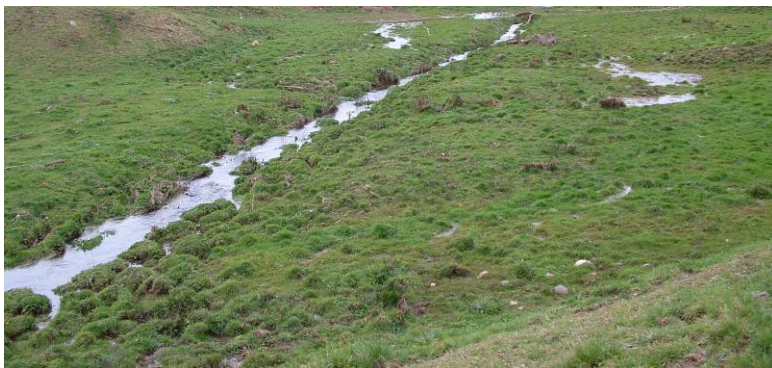
Figure 6.1 Areas of severely pugged ground where retirement into wetlands could be considered to improve water quality downstream (at least during winter and the wetter times of year)

Installing wetlands in boggy parts of paddocks (such as those shown in Figure 6.1 a & b) will be essential to mitigate nutrient and sediment run-off. It has been found in many

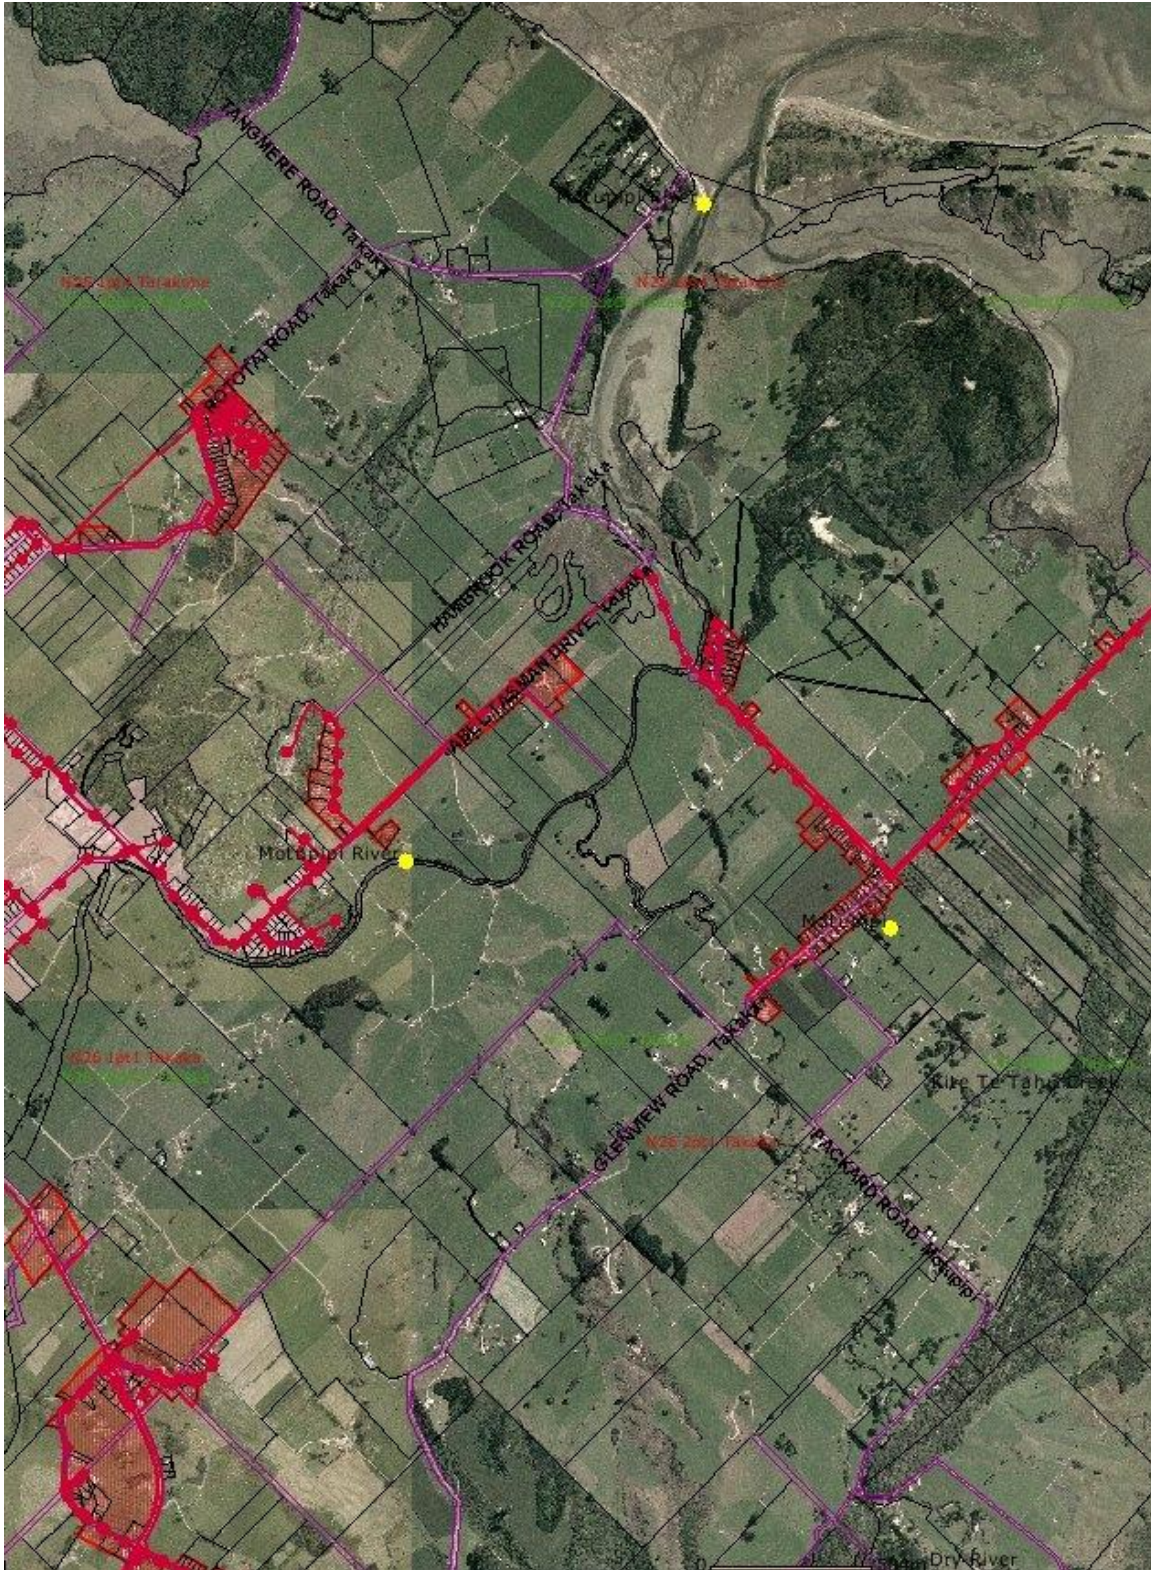
Figure ?? Sewage reticulation network in the Motupipi catchment as at Nov, 2007
